Oak Behaviour in Structural Use

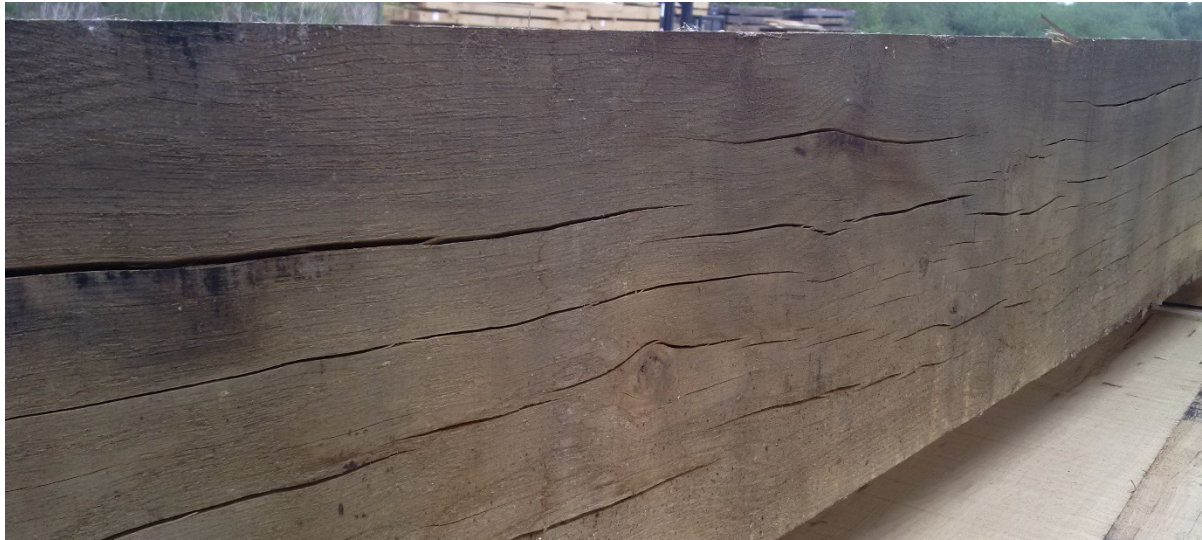
Timber shrinks mostly tangentially, that is, it attempts to shrink around the heart. The most obvious result is the appearance of drying fissures, which appear quite rapidly.

Drying fissures in air dried beam

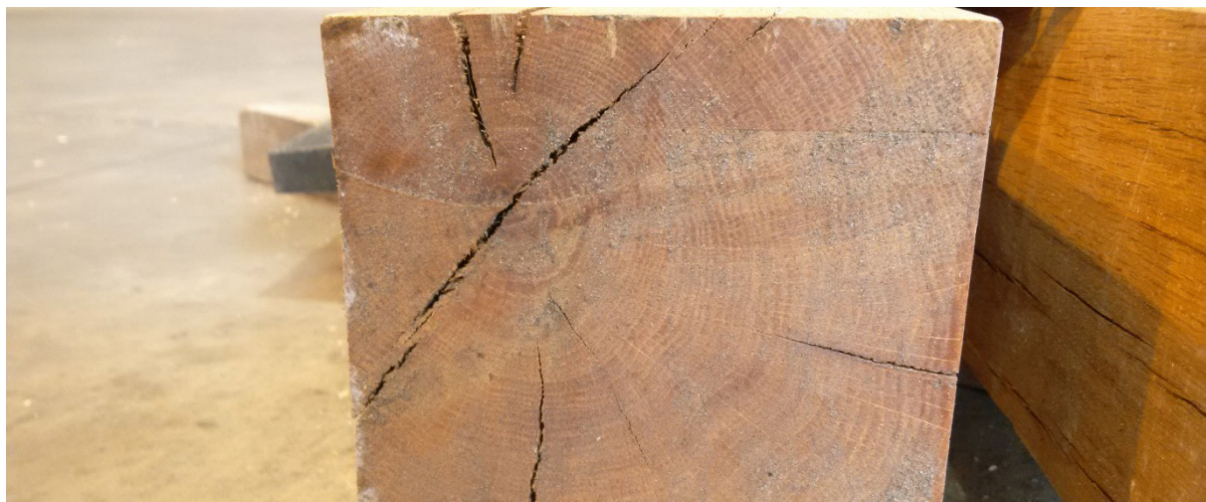
Due to the tangential drying movement, these fissures will reach in towards the heart of the tree, or log, as below.

The fissures will take the shortest route to the heart, oak framers would often historically have put large moulds on the beam, so that fissures would form on an internal corner of a mould, and not be seen.

Most common is 'boxed heart' as the picture above shows where the beam is cut around the heart of the log. This has the advantage of staying reasonably straight and square throughout the drying process, although a slight disadvantage of having more drying fissures.

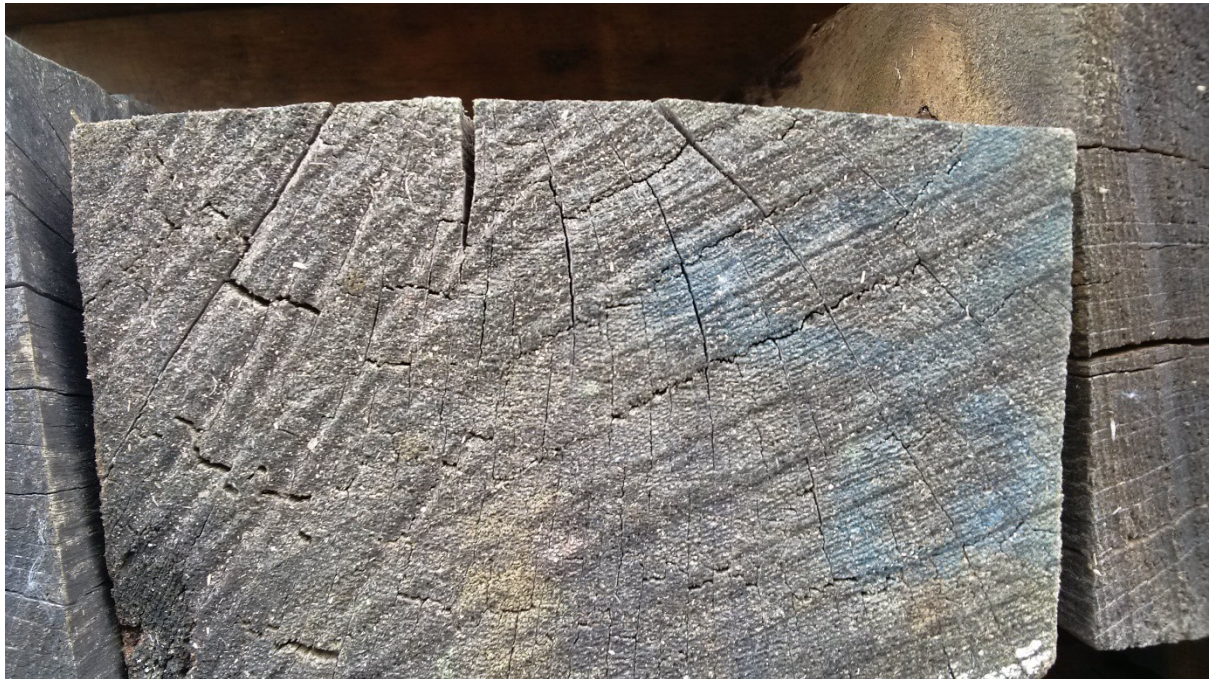
Also reasonably common is 'halved', this is where the log is cut down the line of the heart. The advantage this has, is to minimise fissuring on one face, and the wood

itself is generally stronger and more resistant. However, as it dries, it will form a flattened curve across its section, as the picture below.

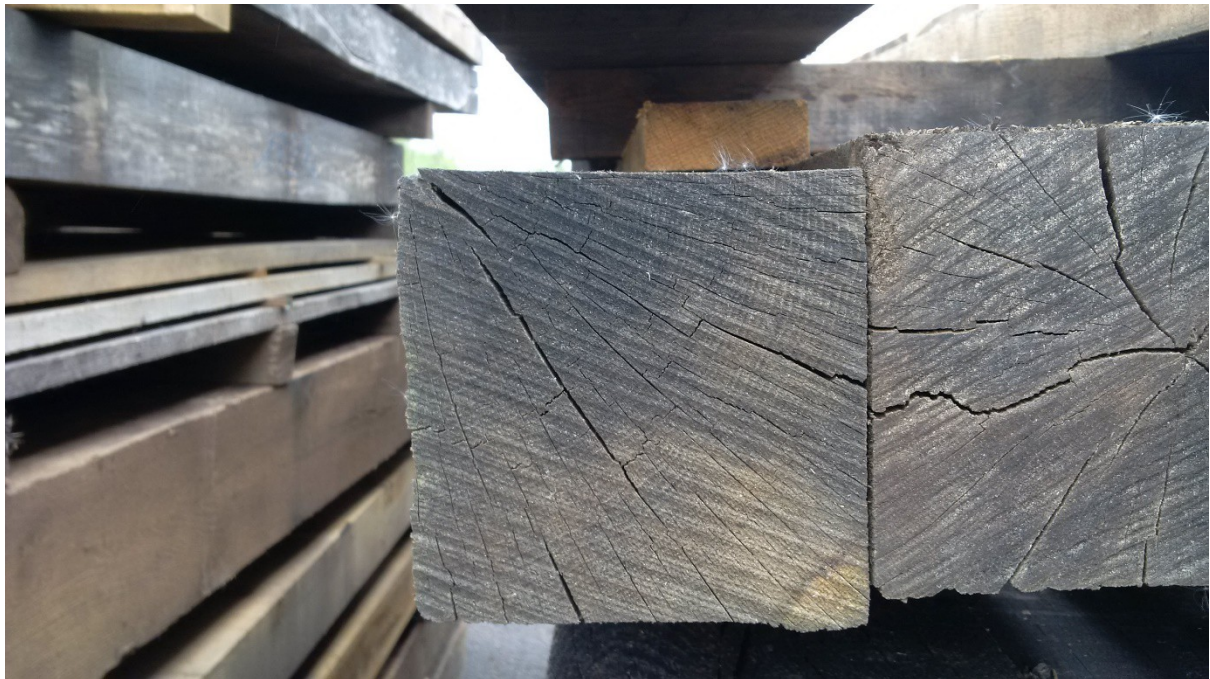
Less common, is the 'quarter' because a beam cut on the quarter needs a large log, and these are more expensive, and less readily available especially in long length. The advantage of this is again, less fissuring, but a disadvantage is the fact that after drying it forms a diamond shape, as the picture below shows.

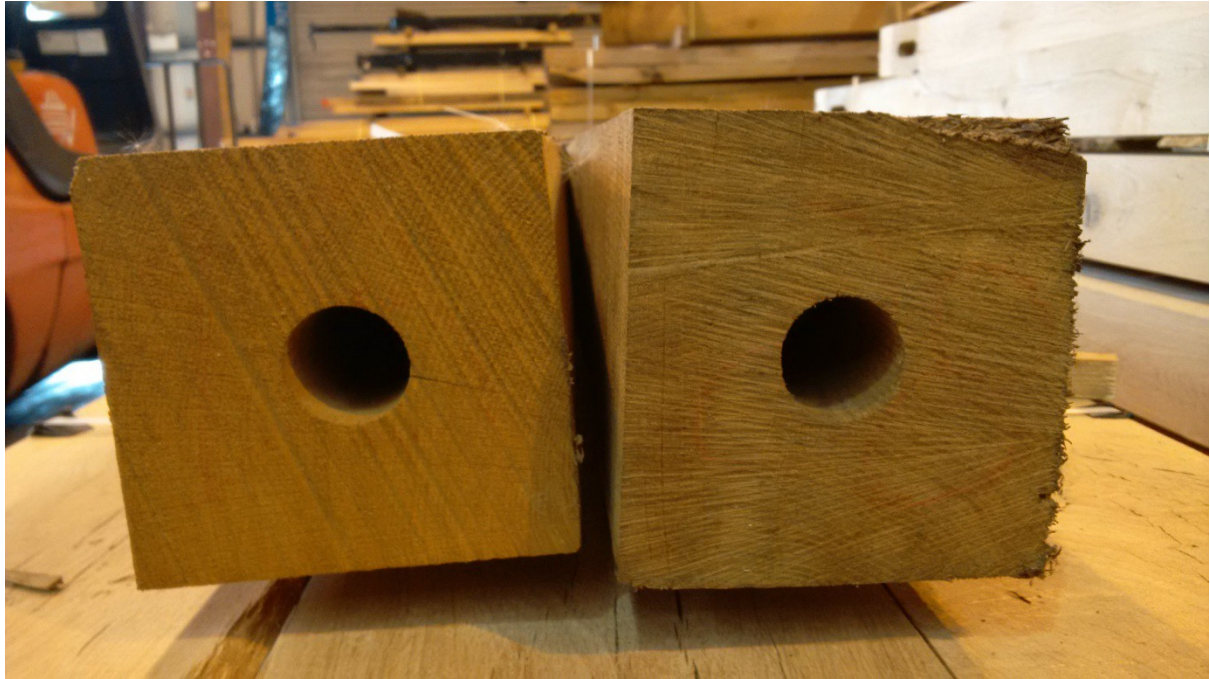
There are ways in which the oak framer can attempt to reduce or eliminate fissuring and movement. Boring out the heart can help, but it has negative effects in that you are removing strength from the wood, which has implications for structural use.

Below are some beams with bored centres, to effectively reduce fissuring. They are not actually cut on the heart, but it has still had a beneficial effect.
